AAD Inspection Corp.

Limited Property Inspection Report

Subject Property: **Street Address, City, State & zip code**

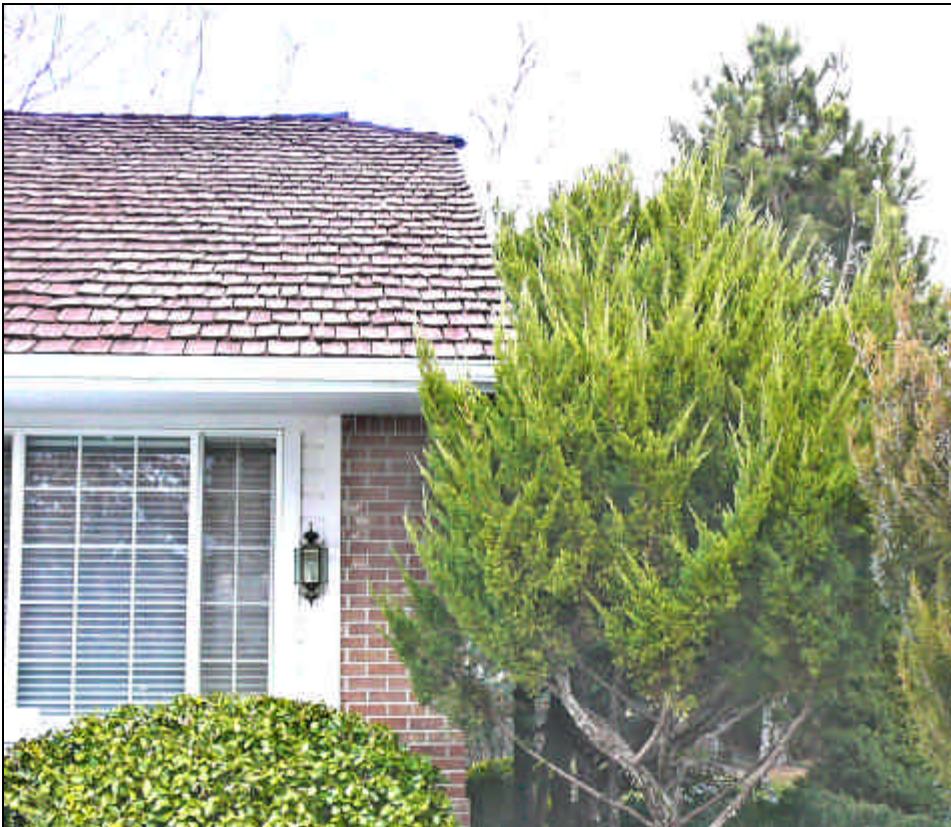
1. The row of junipers planted along the right side of the house has matured enough to begin impinging on the side of the house and soon upon the roof. They need to be trimmed away at this time. As long as these junipers remain in place, they should be trimmed annually to keep their branches from touching the house.

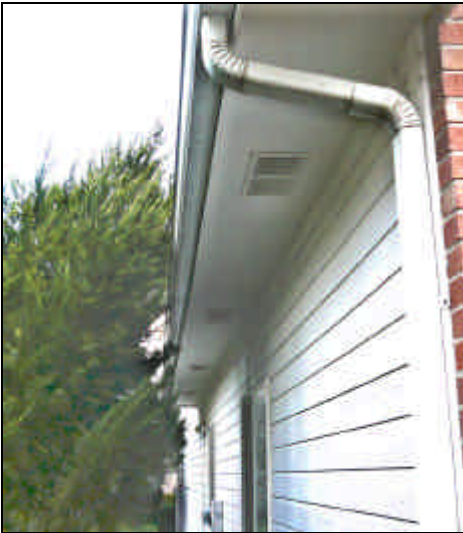
2. The lower 16 inches or so of fiberboard siding is absorbing moisture here and there around the house. Therefore, I suggest taking care at this time to ensure that the bottom edges of the siding are well sealed against water entry. (Please refer to further discussion regarding of maintenance of fiberboard siding, which I have included in the section titled "OWNERSHIP TIPS FOR THIS PARTICULAR HOUSE" near the end of this report.)
3. The juniper tree at the left front corner of the house is impinging on the roof. Its branches should be kept pruned away annually.

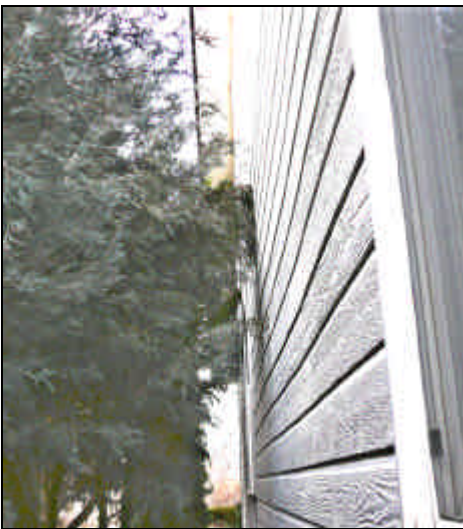
4. The small trees near the left rear corner of the house are impinging on the house and roof. They should be trimmed back annually.

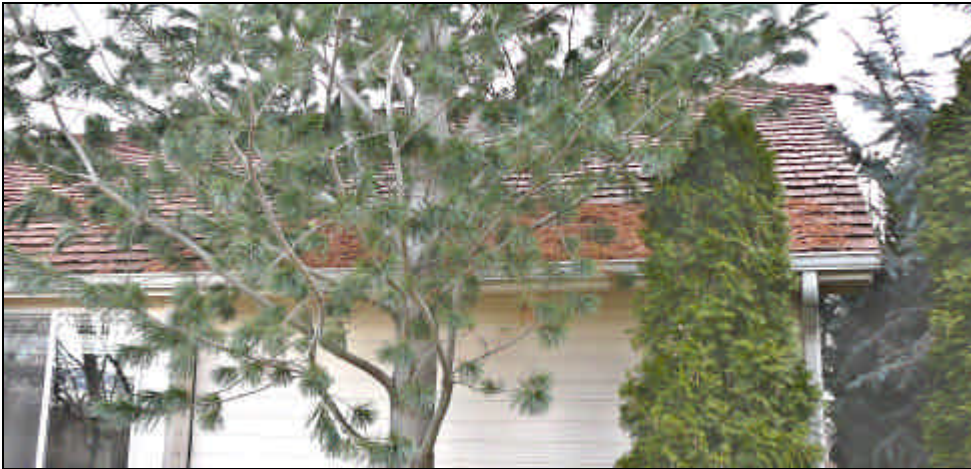
5. The pine tree near the left rear corner of the house may be planted too close to the foundation. As it matures further, its trunk will be pushing on the roof eave. It's also possible that its roots may eventually threaten the foundation. Therefore, I strongly suggest having an experienced tree surgeon address this issue. If this tree is to remain in place, it is important to rake the dead pine needles from the wood roof covering to avoid trapping moisture that may lead to dry rot damage.

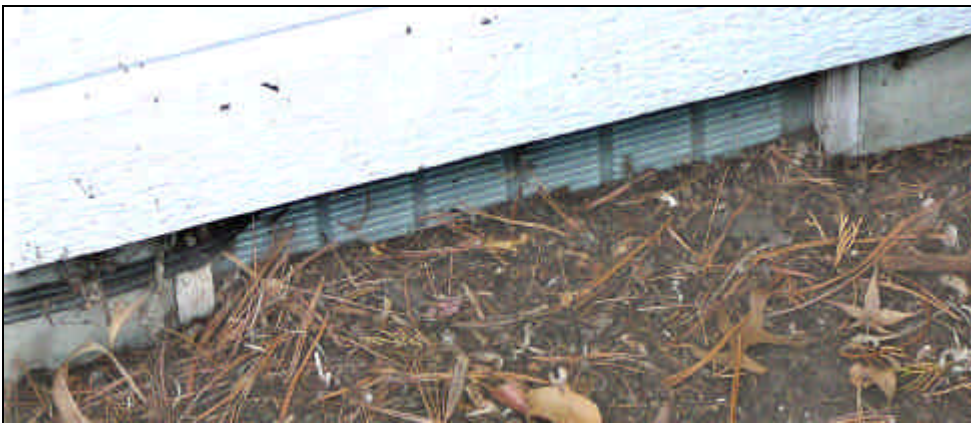
6. A number of foundation perimeter vents are partially covered by landscaping soils. I suggest placing vent wells in front of them.

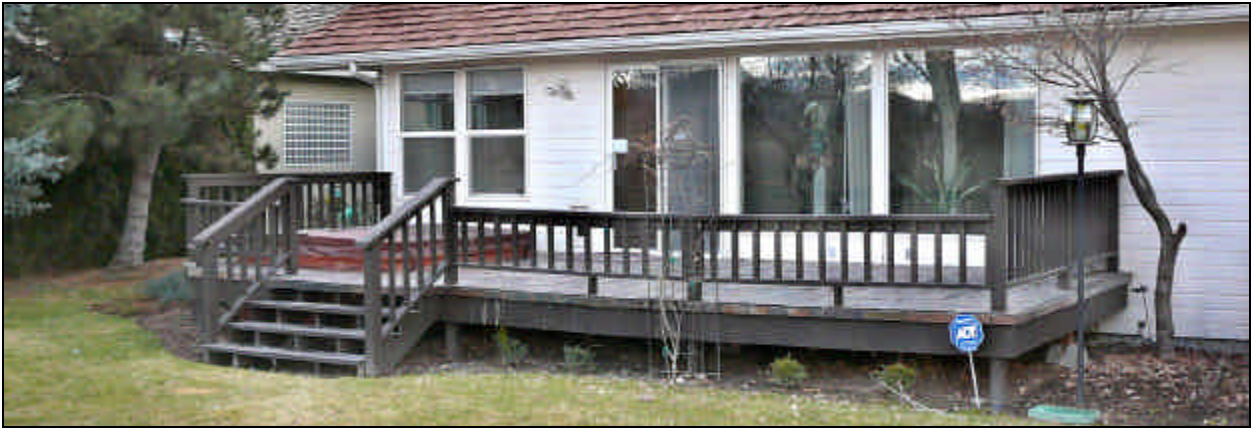
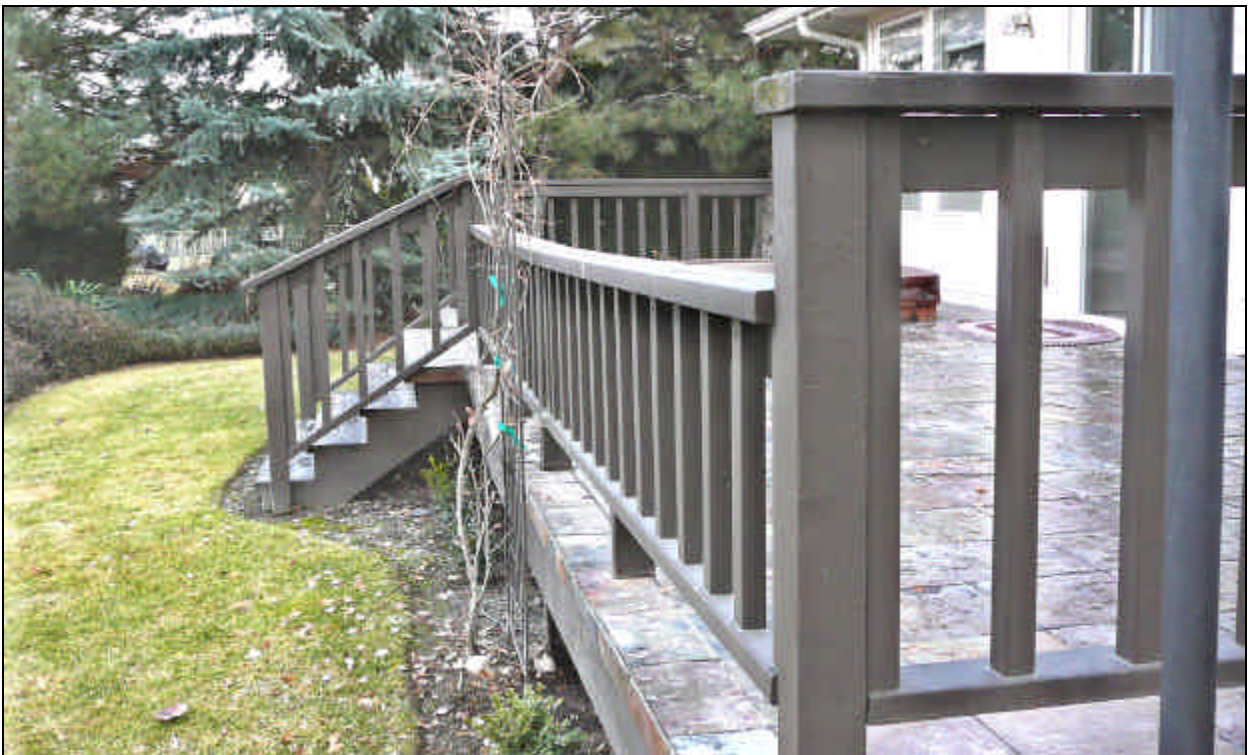
7. Most of the vertical support posts for the redwood deck behind the house appear to have no substantial footings. I suggest temporarily bracing the deck from intermediate posts and replacing the post bases of each permanent footing. I further suggest that masonry footing blocks be placed under each post to avoid direct wood-to-earth contact as much as possible. At this time, the north perimeter of the deck is sagging noticeably due to the lack of support from the posts. This sagging

can be seen in the following two photos.

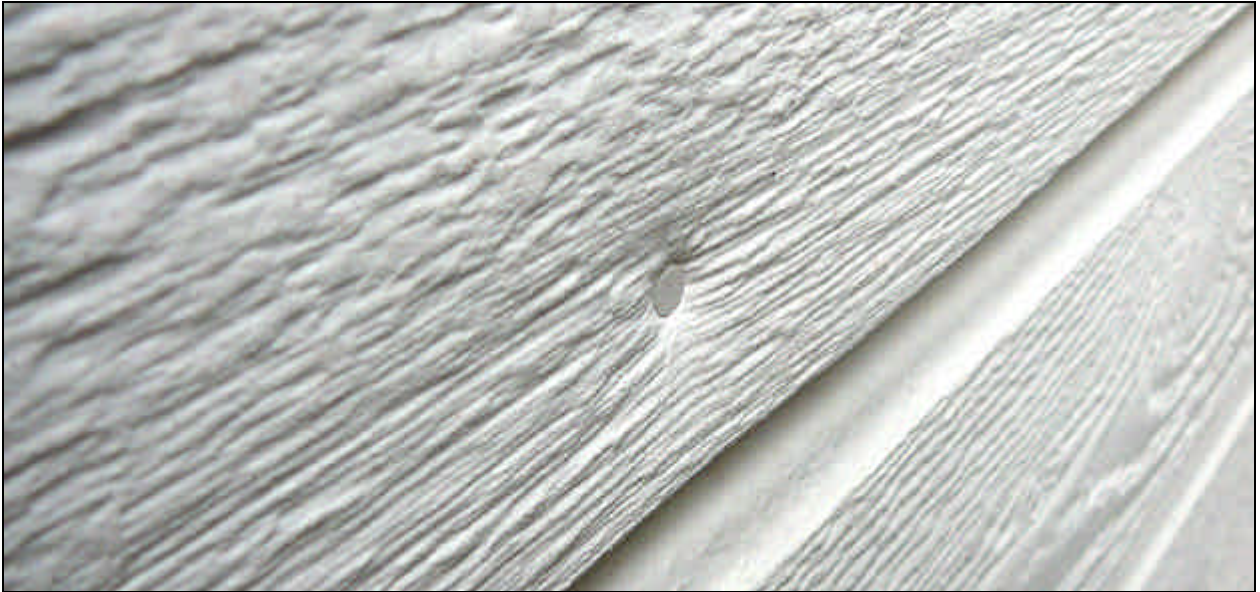
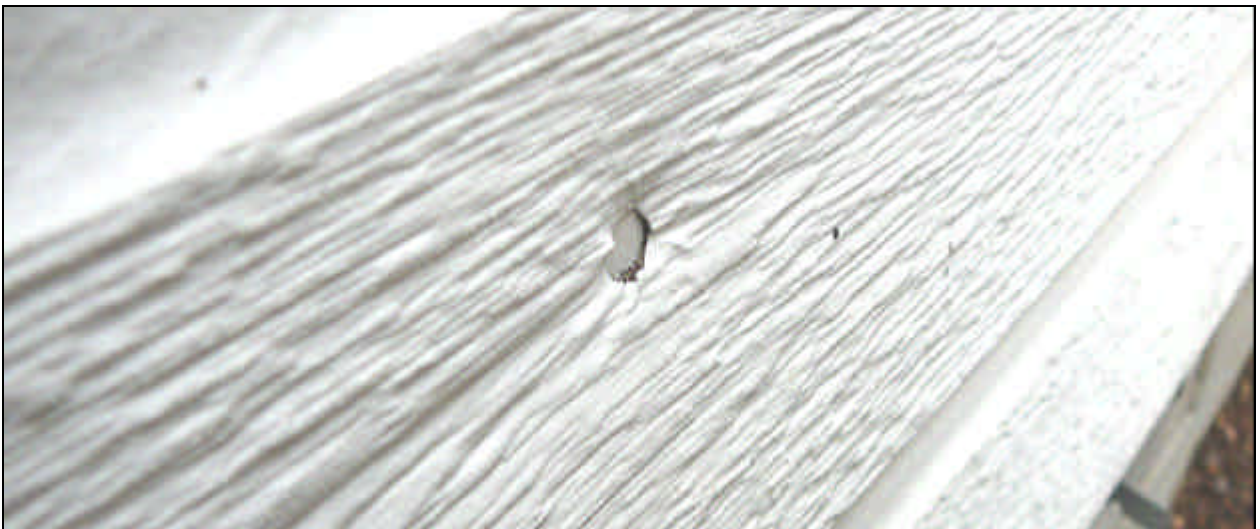
8. Portions of the fiberboard siding (up to about 30 inches from the ground) along the right side of the house have absorbed water enough to cause “pillowing” around the nails. However, at this time the siding still feels rather firm when poked with a screwdriver. I strongly suggest ensuring that all over-driven nail heads are sealed against further water absorption. I also suggest ensuring that the bottom edges of each 16-inch-wide siding strip is well sealed along its bottom edges. (If further

water absorption is stopped at this time, this slight amount of cosmetic distortion to the wood should be acceptable.) The following two photos show close-ups of the siding “pillowed” near nail heads.

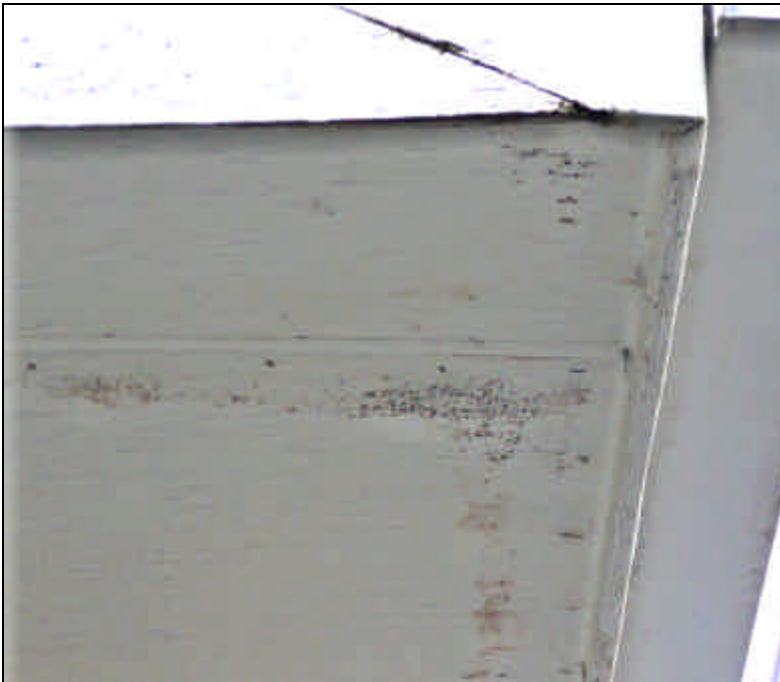
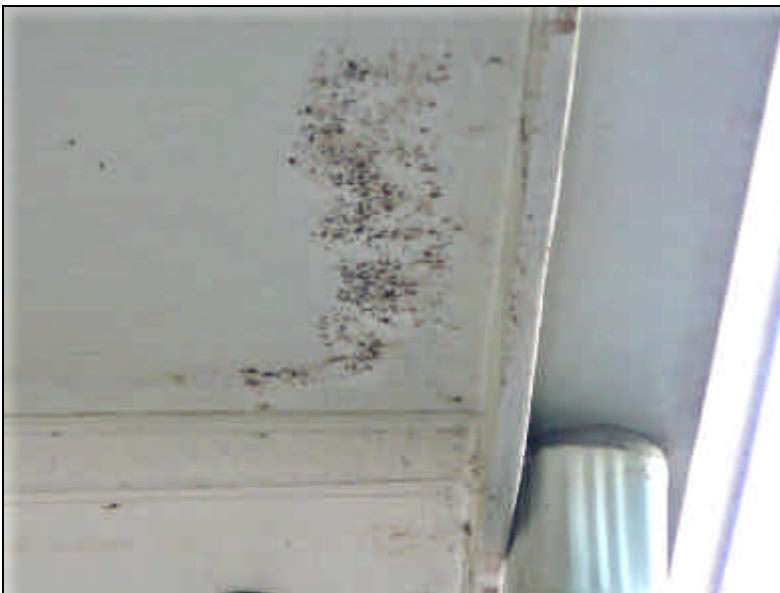
9. It appears that water has been leaking through the cedar shake roof covering, behind the eave fascia, and into the soffit box cavities along the rear of the house, about over the hot tub area. The following two photos show some swelling and discolorations due to this effect. I suggest having a qualified roofing contractor address this issue further. Additionally, similar stains are also noted on the painted

surfaces of the soffit panels at the right front corner of the house. I also noted some similar moisture evidence at the left rear (northwest) corner of the garage. At this time, no real damage has been done to the soffit panels. If the leaks are effectively stopped, the stained areas of the soffit panels should be coated with stain-blocking primer and repainted to reasonably match the surrounding surfaces.

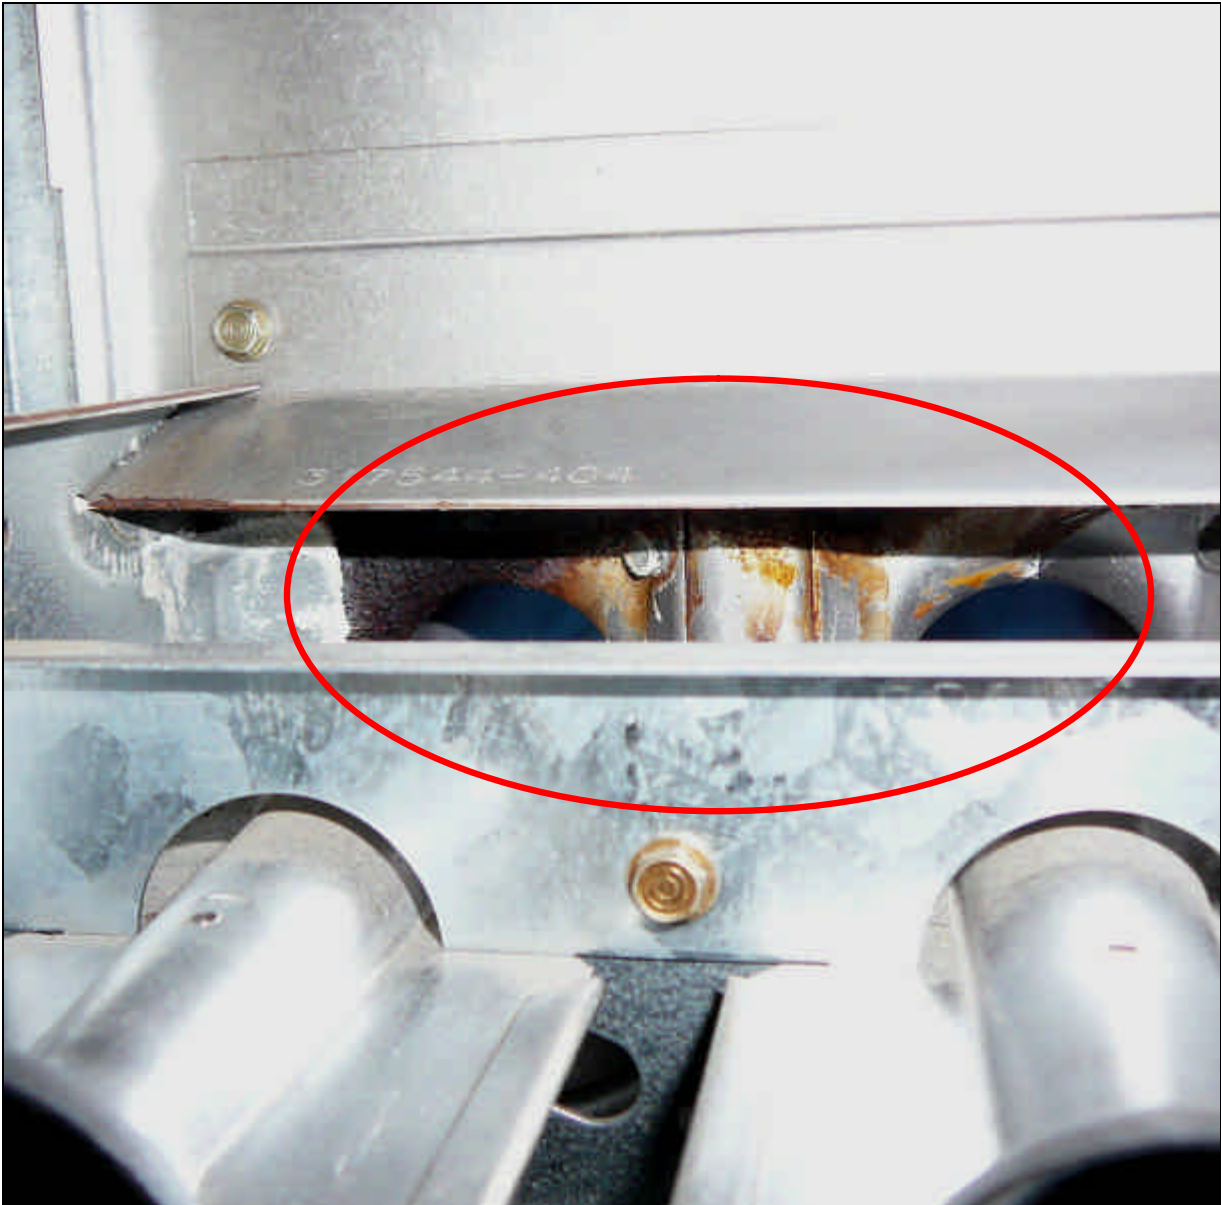
10. The wash sink in the garage is not adequately secured to the wall to protect its plumbing connections. I suggest securing it further.
11. Some corrosion is noted on the front face of the furnace's heat exchanger at the upper left corner of the row of flame ports, as shown in the following photo. I can not explain why the corrosion would have formed at that location. Although I do not perceive any significant threat to the integrity of the furnace due to this corrosion, perhaps a qualified HVAC contractor could lend further valuable insight.

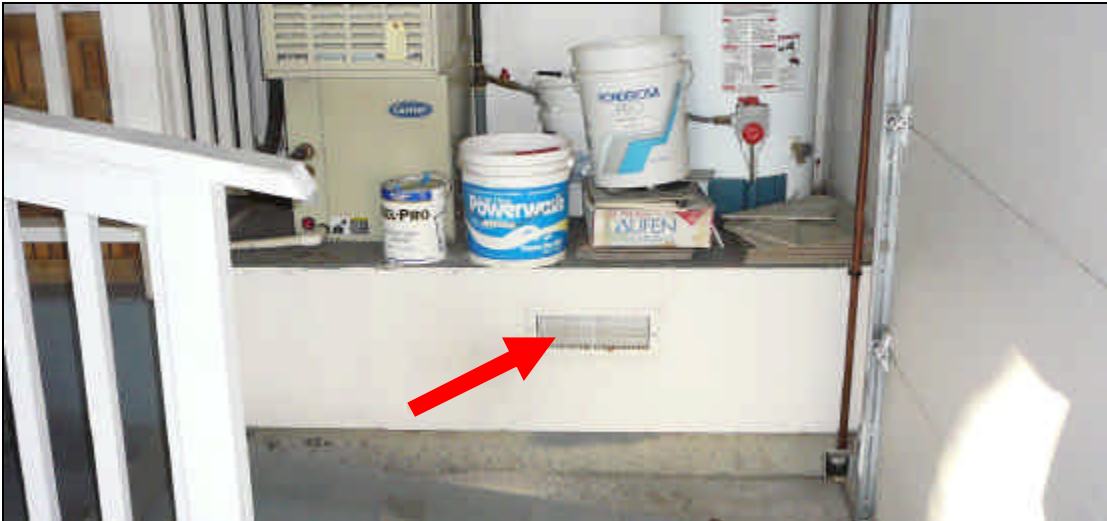
12. The feed-air register brought out into the garage below and in front of the furnace and water heater platform is not allowed by codes. (There should be no direct flame paths between the garage and the house air. Furthermore, this could be a possible route to pass carbon monoxide gasses from the garage into the house.) Therefore, I suggest removing this register or blocking it off. A qualified HVAC contractor should address and/or correct this issue, as necessary.

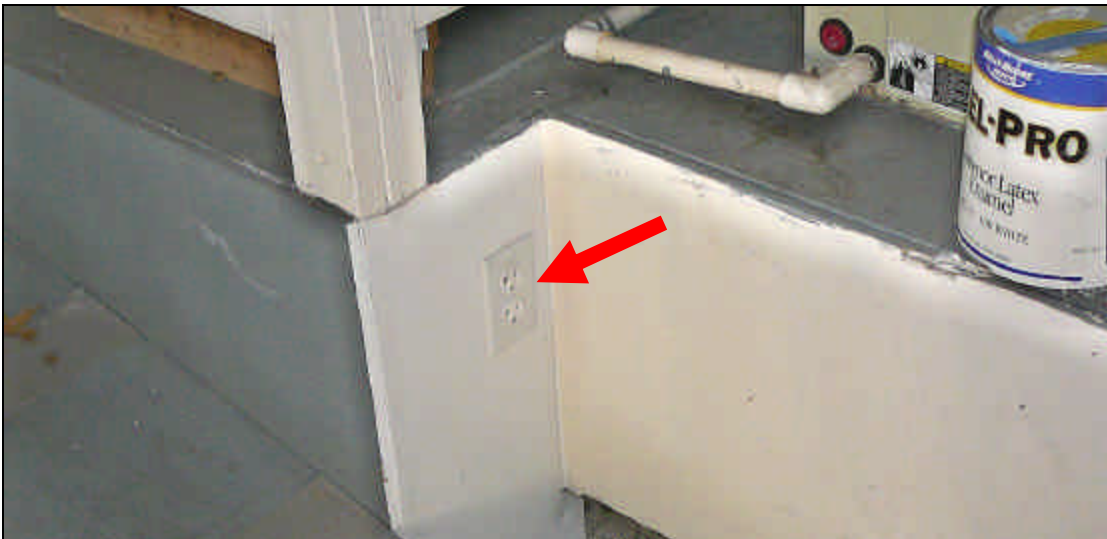
13. The electrical outlet below the front of the furnace in the garage is grounded, but not GFI-protected. A qualified electrician should address and/or correct this issue, as necessary. (This outlet might not remain if and when the wheelchair ramp is removed.)

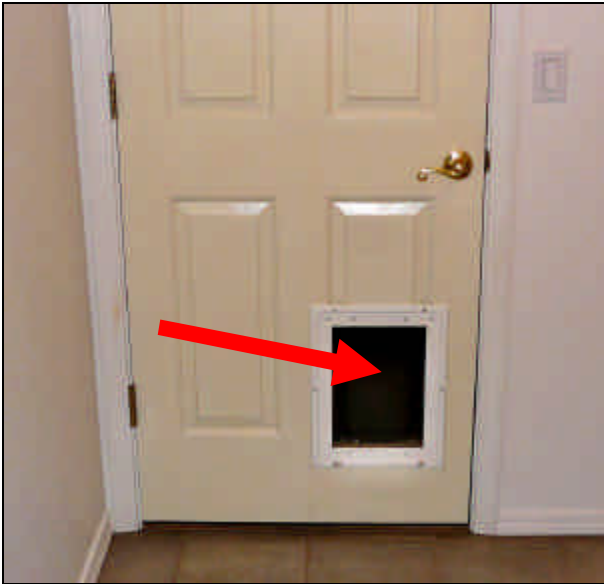
- 14. The pet opening installed through the garage-house entry door reduces the door's ability to perform as a fire barrier. Therefore, I suggest considering replacing the door.

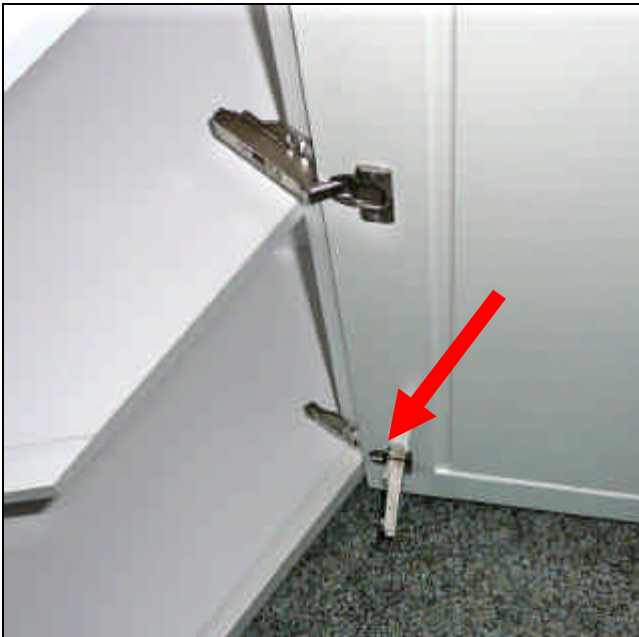
- 15. Part of the bottommost pantry door hinge for the right pair of bifolding doors at the northwest corner of the formal dining room is detached. I suggest having a qualified cabinetmaker or handyman address this issue.

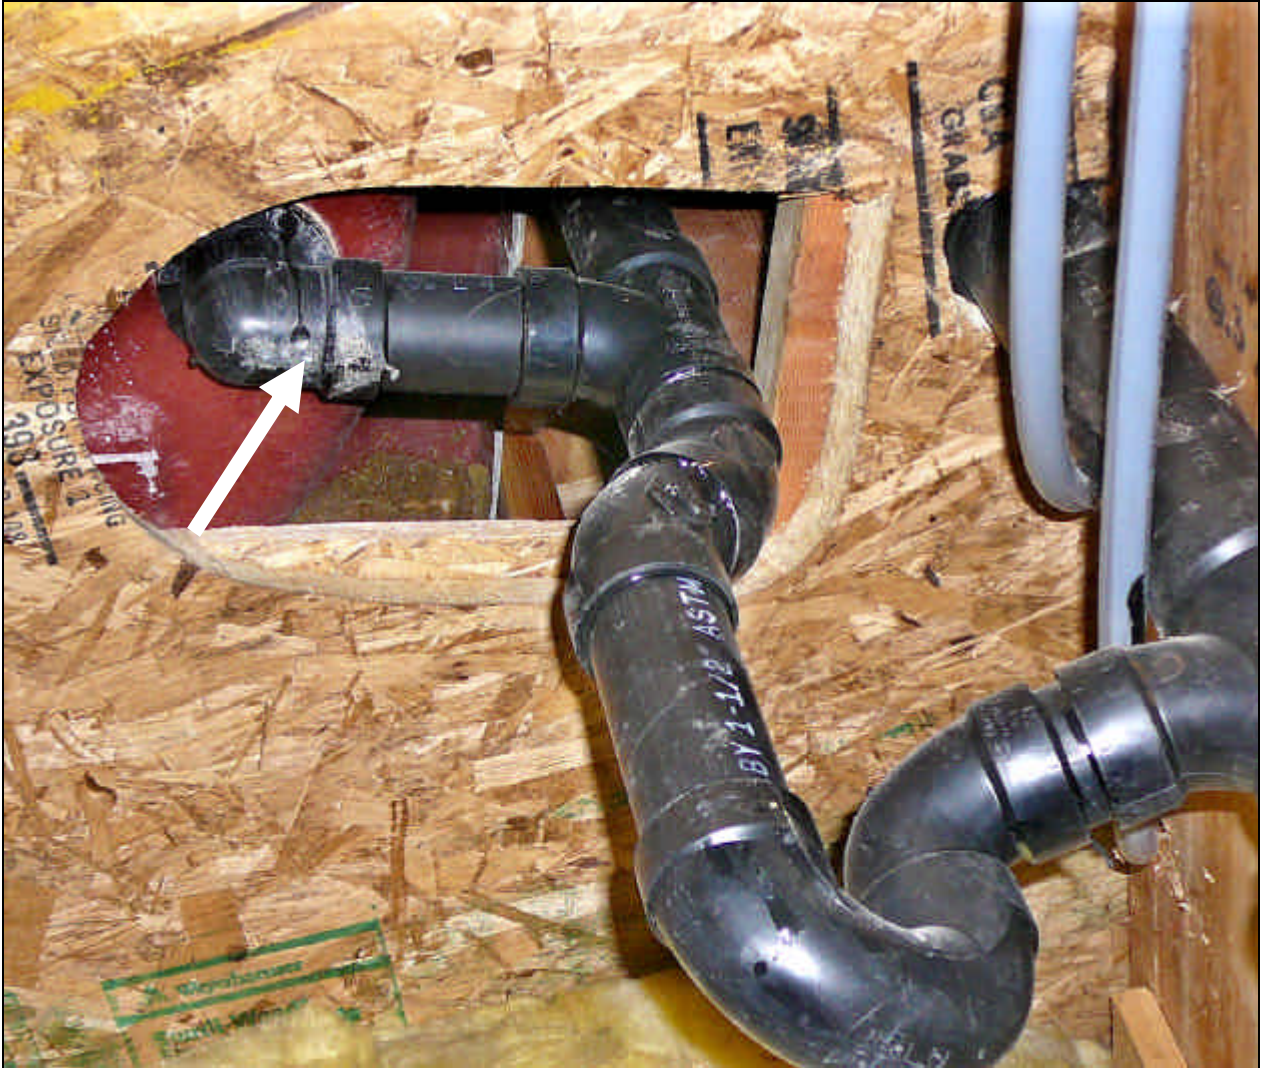
16. The large master bathtub is leaking into the crawl space at its drain flange gasket. A qualified plumber should address and/or correct this issue, as necessary.
